## **Transportation Services Department**

SUBJECT: Berwick Drive Neighbourhood Traffic Management Plan Split Speed Hump Review

Report Number: TS-1	3-12 File Number(s): 750-14-34				
Report Date: Septemb	er 11, 2012 Ward(s) Affected: 1 □ 2 □ 3 □ 4 □ 5 □ 6 ⊠ All □				
Date to Committee: Oc	ober 22, 2012 Date to Council: November 5, 2012				
Recommendation:	Approve that the split speed hump devices on Berwick Drive remain in place, excluding the winter season; and,				
	Approve the use of the split speed hump device as a possible traffic calming device that can be considered on local and collecto roadways during the Neighbourhood Traffic Management (Traffic Calming) Process.				
Purpose:	<ul> <li>Address goal or action in strategic plan</li> <li>Establish new or revised policy or service standard</li> <li>Respond to legislation</li> <li>Respond to staff direction</li> <li>Address other area of responsibility</li> </ul>				
Reference to Strategic Plan:	<ul> <li>☑ Vibrant Neighbourhoods</li> <li>□ Excellence in Government</li> <li>□ N/A</li> <li>Ensure that neighbourhoods and commercial areas, including the downtown, are safe and accessible places to live and gather for activities.</l

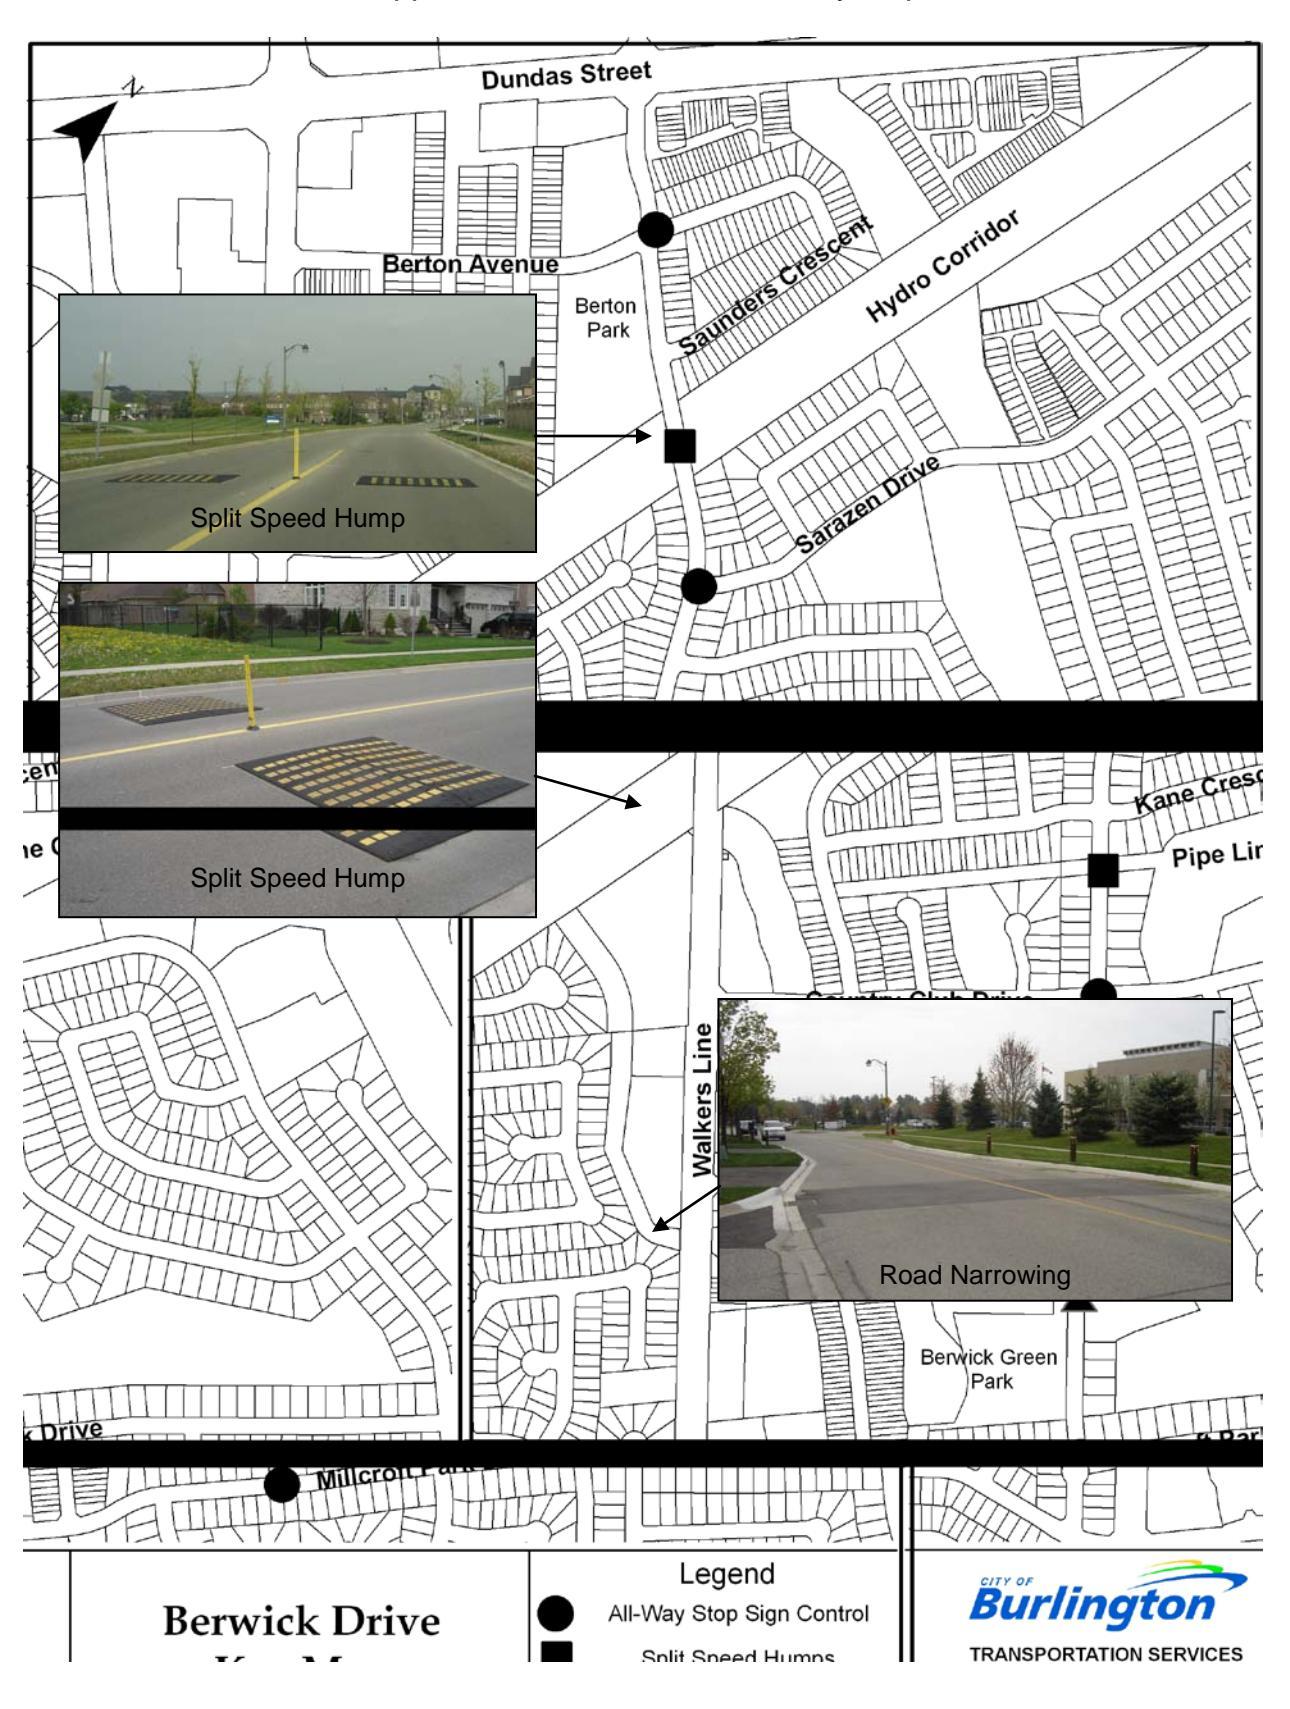
Appendix "A" – Berwick Drive Key Map

Berwick Drive is a 40 km/h two-lane urban collector roadway with direct residential frontage, a school (Florence Meares Public School) and two parks (Berton Park and Berwick Green Park). As a result of the Berwick Drive NTM Plan, two split speed humps were installed in July 2011 and one road narrowing was installed in September 2011 on Berwick Drive, as illustrated in Appendix "A".
